Iranian Journal of Oil & Gas Science and Technology, Vol. 9 (2020), No. 3, pp. 44–60
<http://ijogst.put.ac.ir>

Investigation into Mechanism of Hydrogen Induced Cracking Failure in Carbon Steel: A Case Study of Oil and Gas Industry

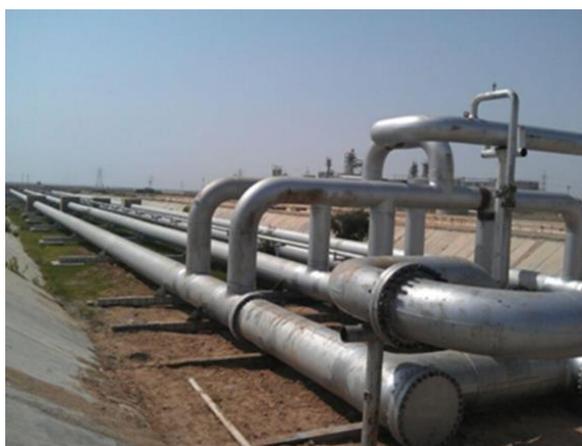
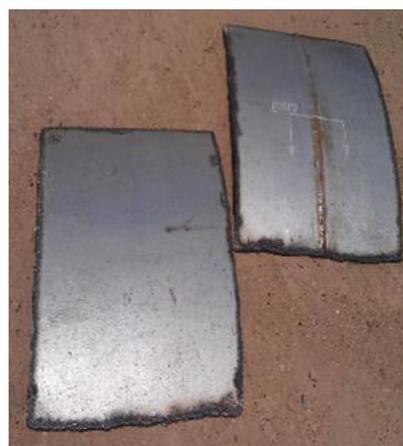
Figure 1

a) A photograph of part of the finger type slug catcher and b) removed samples from the slug catcher.

According to the defect nature and the last NDT results (TOFD and PA) shown in Figure 1(b), some of the most defective areas of welds and base metal of the slug catcher component containing critical defects were extracted and prepared for further nondestructive and destructive testing. Owing to the nature of the HIC defects, a planar shape and orientation in a plane parallel to the major axis of the base metal and a linear zero-degree phased array strategy were selected for flaw detection (Figure 2). Table 2 presents the equipment and test parameters.

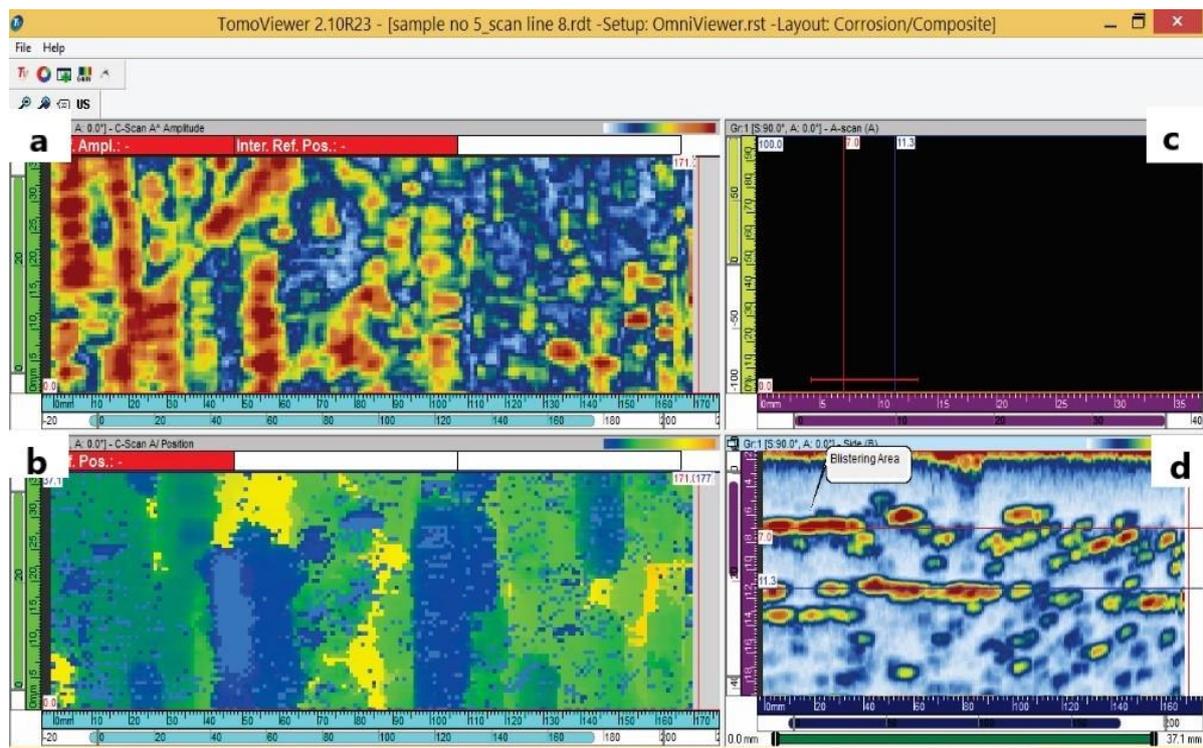
All the scanned data were interpreted in terms of detection, characterization, and sizing. The obtained data interpreted in the particular software provided with the flaw detector system. The interpretation results show that all the samples contain three typical defects, namely blisters, stepwise cracking, and inclusions, in different sizes and locations. Owing to the long service time of the component, the defects were extended through all areas of the base metal. In some cases, all the three types of defects can be seen in one line of the scan. According to the interpretation results, a sample containing sharper defects was selected for further investigations through destructive testing. During sectioning the test piece and after the macro-sectioning, the stepwise cracking and blistering are observed very clearly, and this will be a considerable improvement in all of the phased array setups and interpretations (Figures 7 and 8). Figure 7 presents the corrosion map of scan line 8 shown in Figure 6. Figures 7(a) and 7(b) illustrate the top view of the scan. Figure 7(a) is related to the height of defects or the amount of the returned energy of the reflector, while Figure 7(b) provides detailed information on the depth of a detected material flaw. According to the interpretation of the results, in the range of 0 to 40 mm, the height of ultrasonic pulse is high (orange color), and its depth is close to the center of the cross-section (green color). These symptoms represent severe damage (a blister) in the sample, as shown in Figure 7(d). Figure 8 shows a section of the blistered area after sectioning the sample in the same scanned area of Figure 7. It can be observed that the HIC cracks detected in the studied samples were mostly initiated and propagated through the center or near the center of the cross-section. This segregated zone occurred in the center of the segregation of elements, which is because the external surfaces of the slabs solidify sooner than the internal surfaces during the casting process. Therefore, the elements with a lower melting point are accumulated in the center or near the center of the cross-section.

C-scan, B-scan, and A-scan of the phased array scanned data on the blistered area marked on the image.

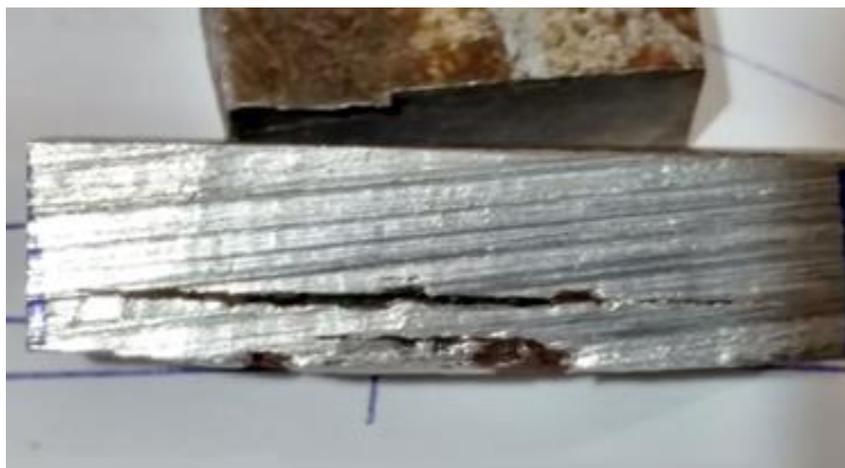
Figure 8

A section of the blistered area after sectioning the sample in the same scanned area of the photo.

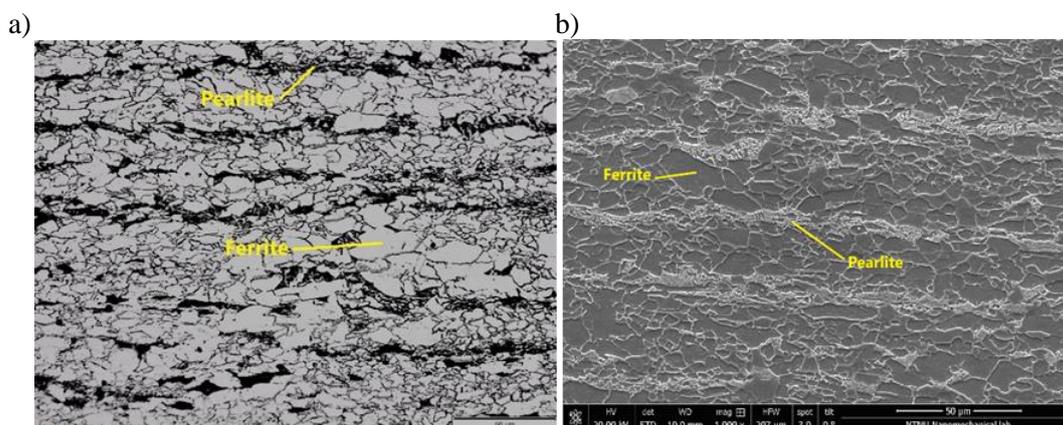
Figure 9

The microstructure of X70QS steel specimen was characterized by an optical microscope and a scanning electron microscope, as shown in Figure 9. The images displayed a massive ferrite microstructure with a grain size ranging from 3 to 30 μm and pearlite bands formed in the microstructure due to the steel rolling process.

a) An optical microscopy image and b) a SEM image of an as-received X70QS steel specimen.

is a brittle phase increasing the strength of steel. Furthermore, as shown in Figure 9, pearlites (the dark phase) were found to be parallel to each other, and the banding phenomenon occurred in the steel structure. This defect is most likely to occur during the rolling process. Further, since the pearlite is a brittle phase, it increases the strength but reduces the fracture toughness of steel; thus, pearlite areas can be prone to nucleation and propagation of the HIC.

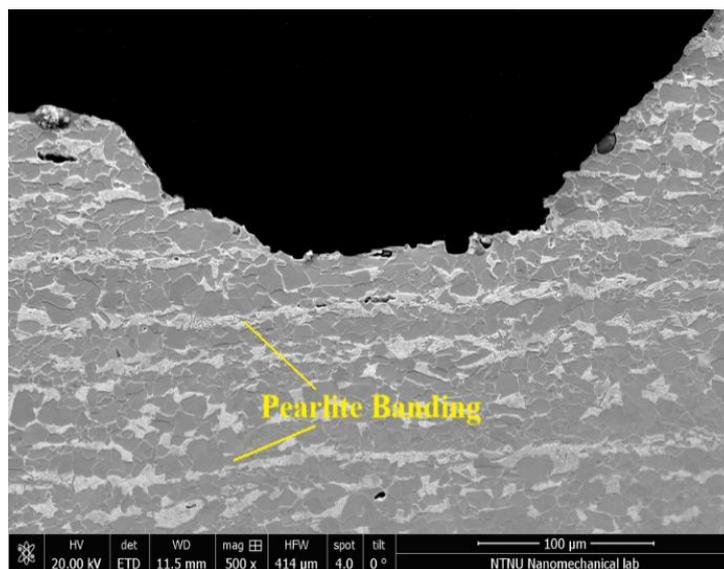
Figure 10

As displayed in Figure 10, the detected HIC in the studied specimen was formed along with the pearlite bands in the direction of the pipe axis. These pearlite bands reduced the resistance of steel to the HIC but increased its hardness by creating hydrogen trapping sites. According to Table 8, the results of the microhardness test on the specimen demonstrate that the hardness has increased in near crack regions, which confirms the diffusion of hydrogen into the hydrogen traps.

Banding phenomenon in the microstructure of the specimen in the direction of the pipe axis.

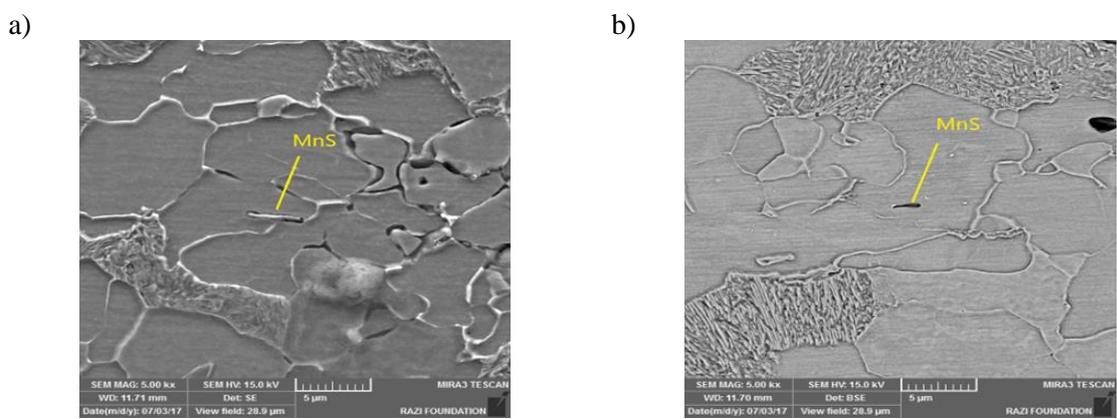
Figure 11

Studies also showed that nonmetallic inclusions are recognized as the main nucleation of HIC cracks (Mohtadi-Bonab et al., 2017). Figures 11–13 reveal the presence of nonmetallic inclusions as nucleation centers of HIC cracks in the specimen. The EDS analysis in Figures 12 and 13 proved that these inclusions were elongated manganese sulfide (MnS) and spherical aluminum oxide (Al₂O₃). MnS is one of the main nucleation sites of HIC cracks. Therefore, the causes of its formation and its features are important. Manganese is added to steel to overcome the deficiency of strength and improve its hot working properties. Furthermore, the presence of manganese facilitates refining and homogenizing the weld region in X70 pipeline steel (Beidokhti et al., 2009). However, the addition of manganese to pipeline steel reduces the resistance of steel to the HIC by the formation of manganese sulfide. MnS has an elongated shape, so it provides a region with a high-stress concentration factor that can facilitate the crack initiation and propagation. Indeed, based on the hydrogen pressure theory (Zapffe et al., 1941; Tetelman et al., 1962), hydrogen atoms can diffuse into the empty region between MnS and metal matrix and combine to make hydrogen molecules, thereby leading to hydrogen pressure buildup.

Presence of MnS inclusions as potential points for HIC crack initiation.

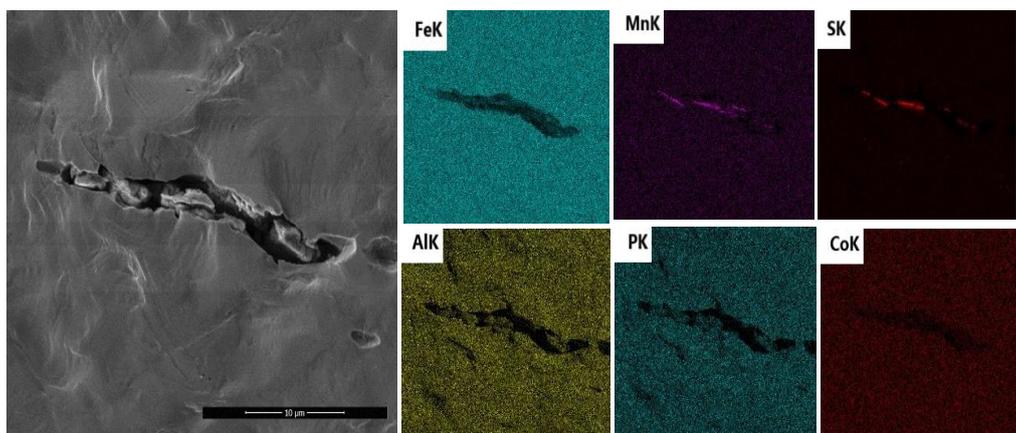
Figure 12

Considering the chemical composition of the as-received X70QS steel specimen (see Table 3), one can observe a high amount of manganese compared to the other elements. Therefore, the presence of elongated manganese sulfide inclusions as potential points for HIC crack initiation in the specimen is inevitable, as shown in Figures 12(a) and 12(b).

(a) SEM image of the HIC crack and MnS inclusions in the specimen and (b) EDS mapping images of the crack area.

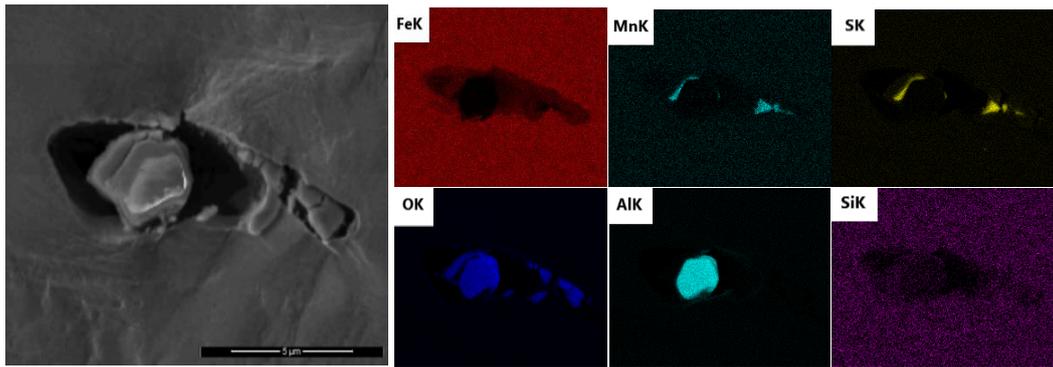
Figure 13

(a) SEM image of the HIC crack and Al_2O_3 inclusion in the specimen and (b) EDS mapping images of the crack area.

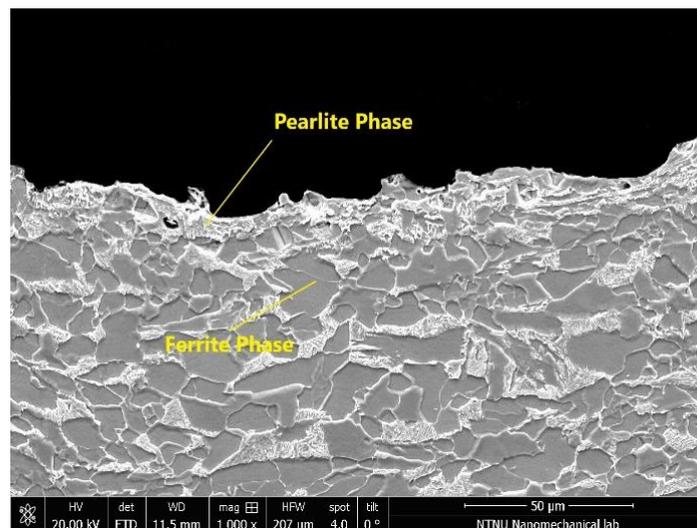
Figure 14

The present study showed that the HIC cracks initially nucleate in nonmetallic inclusions such as manganese sulfide and aluminum oxide, and then harder structures such as the pearlite phase provide an easy path for crack propagation. In fact, these areas provided potential sites for hydrogen trapping. As shown in Figure 14, the HIC cracks were mainly propagated in the pearlite grains or at the interfaces of the ferrite–pearlite phases. Therefore, the optimum determination of the amount of important elements such as manganese, sulfur, and aluminum in the manufacturing process is necessary to improve the mechanical properties and resistance of steel pipes and equipment to the HIC.

Propagation path of the HIC in pearlite or at the interfaces of the ferrite–pearlite phases.
