Iranian Journal of Oil & Gas Science and Technology, Vol. 10 (2021), No. 4, pp. 31–42
<http://ijogst.put.ac.ir>

Failure Mechanisms and Solutions for Fin-Pass Rolls Repair-Ring at an Electric Resistance Welding Pipe Plant

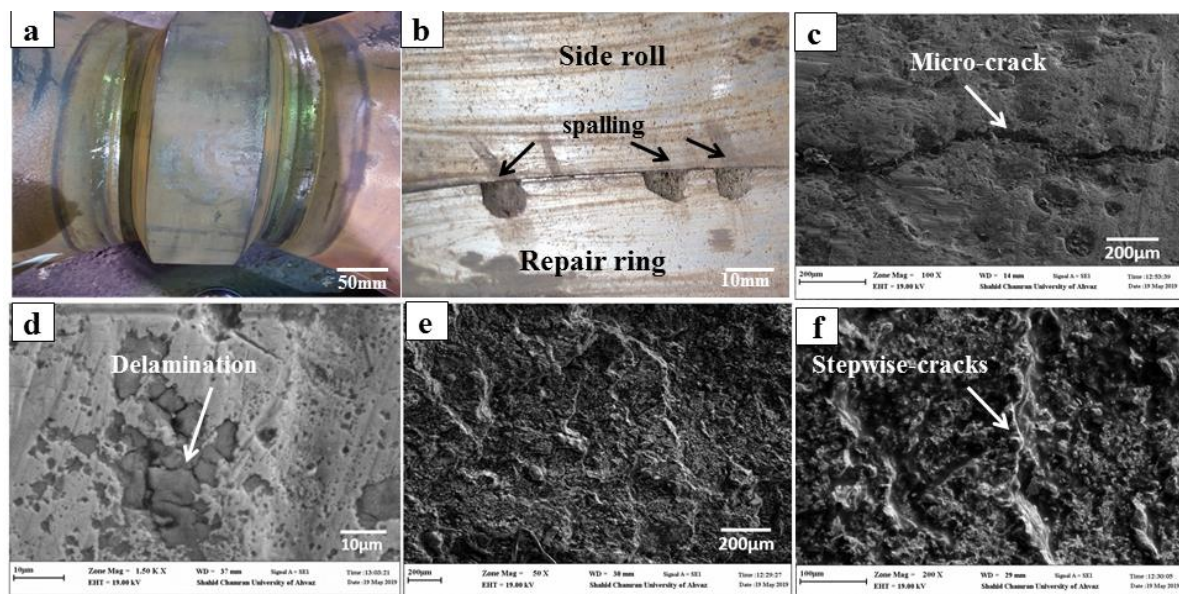
Figure 2

In order to identify the causes of damage to the fin-pass rollers, a detailed visual examination of their surface was performed in the damaged areas. The results are shown in Figure 2. Figure 2a shows a macroscopic image of the fin-pass roller repaired using repair rings after one year of service. The partial signs of wear are visible on the surface of side rolls, which has a minor effect on the performance of the fin-pass rolls and can be neglected. However, it is evident in higher magnification (Figure 2b) that spalling has occurred on the edge of the repair ring, resulting in detrimental effects on the performance of the fin-pass rolls. In addition, the spalled regions could lead to stress concentration and finally result in fracture. For closer investigation, scanning electron microscopy images were taken from the surface of repair rings at the damaged sites to identify the destruction mechanism.

Macroscopic and microscopic images of the damaged surface of the fin-pass roller: a) magnification $\times 0.1$ (optical); b) magnification $\times 10$ (optical); c) electron microscopic image of the not spalled edge regions (SEM); d) electron microscopic image of the dull edge regions with $\times 500$ magnification (SEM); e) the same specimen at $\times 1000$ magnification (SEM); f) Fin-pass roller electron microscopy image in non-edge areas (SEM).

Figure 2c shows the surface morphology of the roller in areas with no spalling signs at $\times 100$ magnification. A surface microcrack is visible. At a higher magnification ($\times 150$) (Figure 2d), some minor grooves and soft dull edges can be seen, showing minor delamination and abrasive wear. In the delamination mechanism, cyclic stresses accumulate work hardening beneath the surface, resulting in the initiation and propagation of microcracks from the subsurface regions to the outer surface. In these

conditions, negligible wear is observed indicative of high wear resistance of the repair ring (made from AISI D2 steel), which has no significant effect on the performance of the fin-pass rolls. Figure 2e illustrates the scanning electron micrographs of the spalled area of the repair ring at its edge. In addition, a higher magnification image is shown in Figure 2f, which reveals the signs of the stepwise crack growth pattern, which can indicate that the crack growth occurs by the fatigue mechanism. The collision of the edge of the sheet with the revolving repair ring during the forming process caused cyclic stresses that led to the beginning of fatigue. In addition, stress concentration at the edge of the repair rings can increase the cyclic stress level and intensify the fatigue crack growth. The fatigue cracks probably nucleated from the surface and grew inwards, causing the spalling at the edges of the repair rings (Premsai 2014). The mild surface grooves or delamination-induced slits are prone to stress concentration, initiation, and growth of the fatigue cracks. The negligible effects of wear on the surface of the repair ring are signs of the high wear resistance of AISI D2 steel. However, the occurrence of spalling at its edge in a shorter time than the AISI 8622 steel (original material of the side roll) demonstrates the low fatigue resistance of AISI D2 steel due to the low toughness of the AISI D2 alloy, which results in its spalling and eventually leads to the fracture of the repair ring.

As mentioned in the failure analysis section, a potential solution to extending the service life of the repair ring is to use an alternative material with higher toughness and to use a suitable surface treatment to achieve higher wear resistance. This study proposed low-carbon AISI P20 steel and medium-carbon AISI 4140 steel alloys with higher toughness than high-carbon AISI D2 steel. For low-carbon steels, surface carburization and medium-carbon steels case hardening and hard chromium plating can be suitable surface treatments to increase the wear resistance. Thus, the carburization of AISI P20 steel, the case hardening, and the hard chromium electroplating operations on AISI 4140 steel were performed. Figure 5a shows the cross-sectional morphology of the case hardened AISI 4140 steel. Further, Figure 5b and 5c shows the microstructure of the near-surface areas and the deeper portions of this specimen at higher magnification, respectively. Observation of martensite blades on the surface of this steel can lead to high surface hardness. In addition, the pearlite-ferrite microstructure in the deeper portions can indicate the high toughness in these areas.

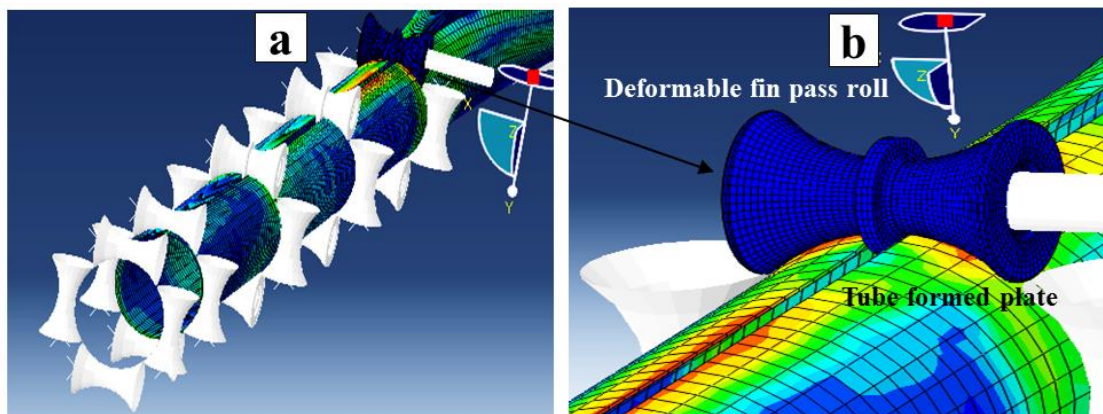
Figure 3

The results of the finite element analysis of Von-Mises stress: a) pulling the tubular formed sheet between the forming rollers; b) the investigated first row fin-pass rollers with a deformable element at a higher magnification.

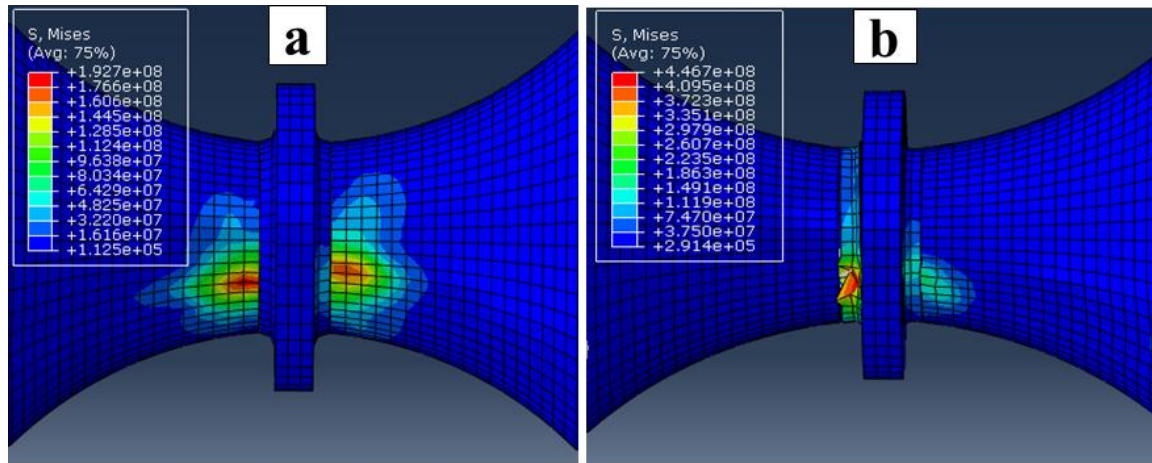
Figure 4

Figure 4a to 4b shows the Von-Mises stress distribution at different roller components of three and five using the repair rings. For better viewing, the sheet is omitted, and only the first row of the fin-pass roller is shown. Figure 4a shows the Von-Mises stress distribution of the fin-pass roller without repair rings three-piece mode. The maximum Von-Mises stress is 180 MPa in this case. Figure 4b shows the Von-Mises stress distribution of the fin-pass roller with repair rings (five-piece mode). The maximum stress value is 440 MPa, which is significantly higher than the value (180 MPa) at the fin-pass roller without repair rings (Figure 4b). Comparing Figure 4a with 4b shows that increasing the number of

roller components from three to five using the repair rings increases the maximum stress value, especially at the repair ring due to the low width of the ring and the synergy of the interfacial stresses at its edges increasing the mean stress. It indicates that repair rings are further prone to failure and fracture due to higher stress concentration. In this case, the higher values of the stresses will facilitate the initiation and growth of the fatigue cracks and thus shorten the lifetime, which agrees with the observation of spalling in a shorter time at the edges of the repair ring than the edge of the side roll.

Distribution of Von-Mises stresses for fin-pass roller without repair ring (three-piece roller) at different values of the friction coefficient between its components: a) $W_r = 0$; b) $W_r = 0.5$; c) $W_r = 1$; d) distribution of Von-Mises stresses for fin-pass roller with repair rings (five-piece roller) at values of 0.5 for friction coefficient between its components.

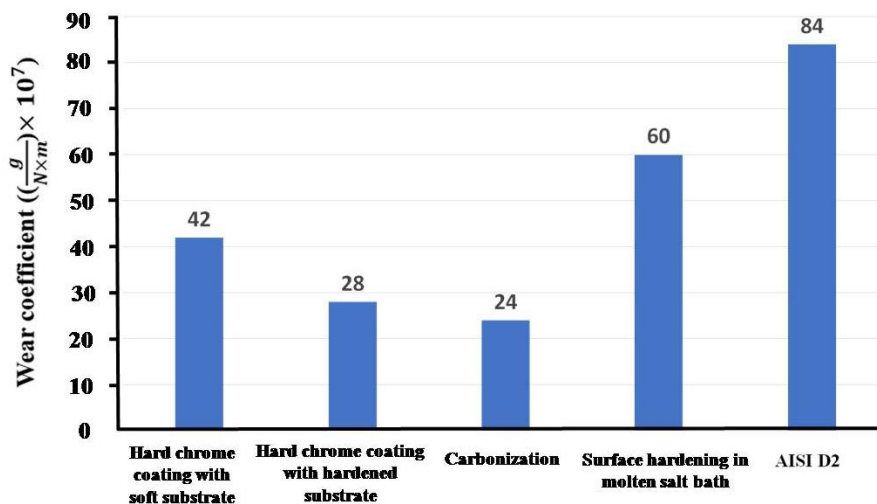
Wear coefficient of the various steel samples.

Figure 7 shows the wear coefficient of the hard chromium electroplated AISI 4140 steel, case hardened AISI 4140, and carburized AISI P20 and AISI D2 steel. Moreover, for a better understanding of the

wear mechanism, the SEM images of the worn surfaces of these samples are shown in Figure 8. As shown in Figure 7, the wear rate of the carburized AISI P20 sample is lower than the other samples, which indicates the better wear resistance of this sample. At the subsequent levels, the hard chromium electroplated AISI 4140 steel the case hardened AISI 4140 sample has the following low wear rates. The highest wear rate is for the AISI D2 steel specimen. For a better interpretation of the wear mechanism of the different specimens, the worn surface of the specimens was examined using scanning electron microscopy in Figure 8 at different magnifications.

According to the results of the wear tests, the carburized AISI P20 sample showed the highest wear resistance compared to the other specimens. Therefore, manufacturing the repair rings from AISI P20 steel and carburizing its surface are an excellent solution to improving its service life, which can improve the performance of the fin-pass rollers after the repairing process.

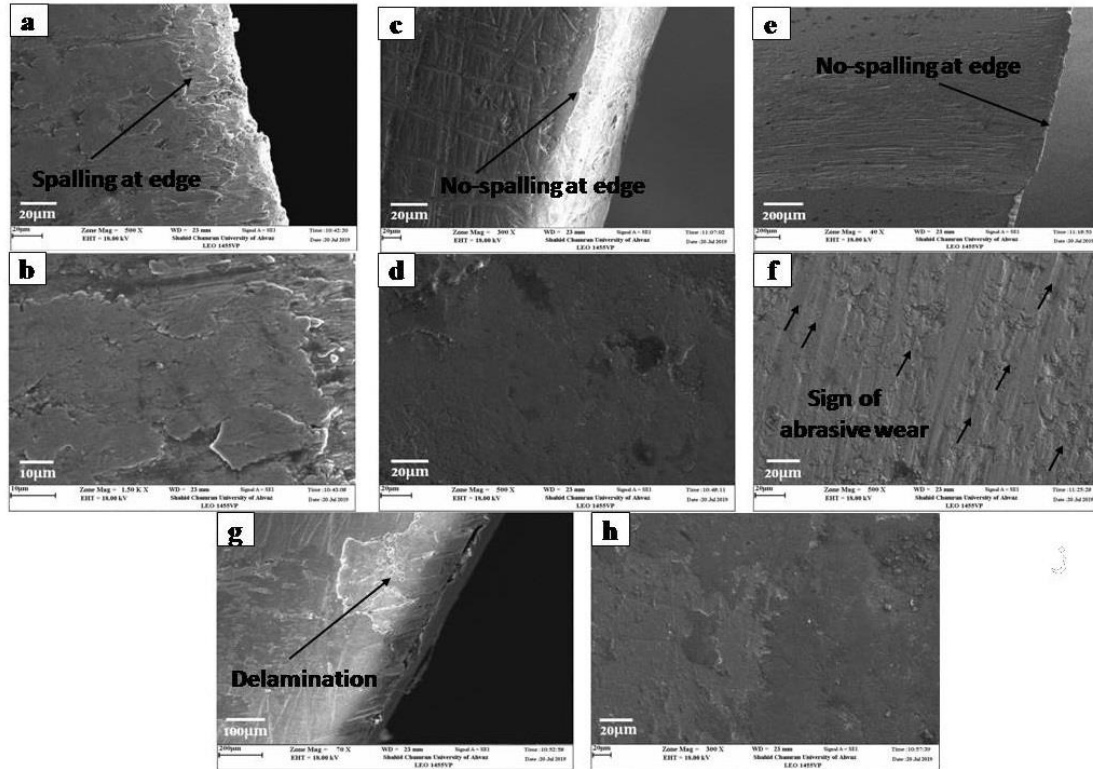
Figure 8

Scanning electron microscopy images of a) the edge of the wear test specimens of AISI D2 steel, b) the worn surface of AISI D2 steel, c) the edge of the carburized AISI P20 specimens, d) the worn surface of the carburized AISI P20 steel, e) the edge of the wear test specimens of the case hardened AISI 4140 steel, f) the worn surface of the case hardened AISI 4140 steel, g) the edge of the wear test specimens of the hard chromium electroplated AISI 4140 steel, h) the worn surface of the hard chromium electroplated AISI 4140 steel.

According to Figure 8a, spalling occurred at the edge of AISI D2 steel due to the inherent low toughness of this steel that cannot withstand the stress concentration of the wear test. In addition, the mild effects of wear at higher magnifications can be seen (Figure 8b). Observation of the highest wear rate for this specimen can be attributed to the occurrence of spalling that causes significant weight loss. Figure 8c shows the worn surface of the edge of the carburized AISI P20 wears test specimen. No spalling has taken place. The reason is the gradual increase in toughness from the surface to the depth of this specimen due to the gradual change of the microstructure from martensitic to pearlitic–ferritic one. In this case, with a gradual increase in toughness from the surface to the depth, the specimen becomes more resistant to the growing microcracks (Cavaliere, 2008; Savrai, 2021). In addition, according to Figure 8d, the worn surface of this specimen is very smooth, which is in agreement with the observation of the highest wear resistance for this specimen than the others. The smoothness of the worn surface indicates that the specimen could overcome the sliding wear mechanism, and adhesive and abrasive

wear are not significant due to the high hardness of the martensitic microstructure and the high carbon concentration of the surface layers, leading to high wear resistance (Hotz, 2020).

Figure 8e and 8f shows the worn surface images at the edge and surface of the case hardened AISI 4140 steel, respectively. No spalling could be seen at the edge of the specimen. However, signs of abrasive wear are noticeable on the surface of the sample related to the lower hardness of this specimen than the carburized AISI P20 steel. Figure 8g and 8h shows the worn surfaces at the edge and surface of the hard chromium electroplated AISI 4140 steel, respectively. No spalling happened on the edge of the test specimen. However, some delaminating of hard chromium coating is observable, which may be related to the high residual stresses of the hard chromium coating, which are accompanied by high values of stress concentration at the edges and led to the removal of the coating. The high internal stress of the hard chromium coatings is related to the stresses encountered during the electroplating process. The high current density causes the atoms not to be in equilibrium during electroplating, leading to high internal stresses (Andrew, 2021; Pfeiffer, 2011). However, the worn surface of this specimen is smooth, and there are negligible effects of severe abrasive and adhesive wear, which agrees with observing good wear resistance for this sample after the carburized AISI P20 steel specimen.
