## Failure Investigation of Hydrogen Blistering on Low-strength Carbon Steel

E. Shekari<sup>1</sup>, M. R. Shishesaz<sup>1\*</sup>, Gh. Rashed<sup>1</sup>, M. Farzam<sup>1</sup>, and E. Khayer<sup>2</sup>

<sup>1</sup> Department of Technical Inspection Engineering, Petroleum University of Technology, Abadan, Iran

<sup>2</sup> Iranian Offshore Oil Company, Bahregan Oil District, Iran

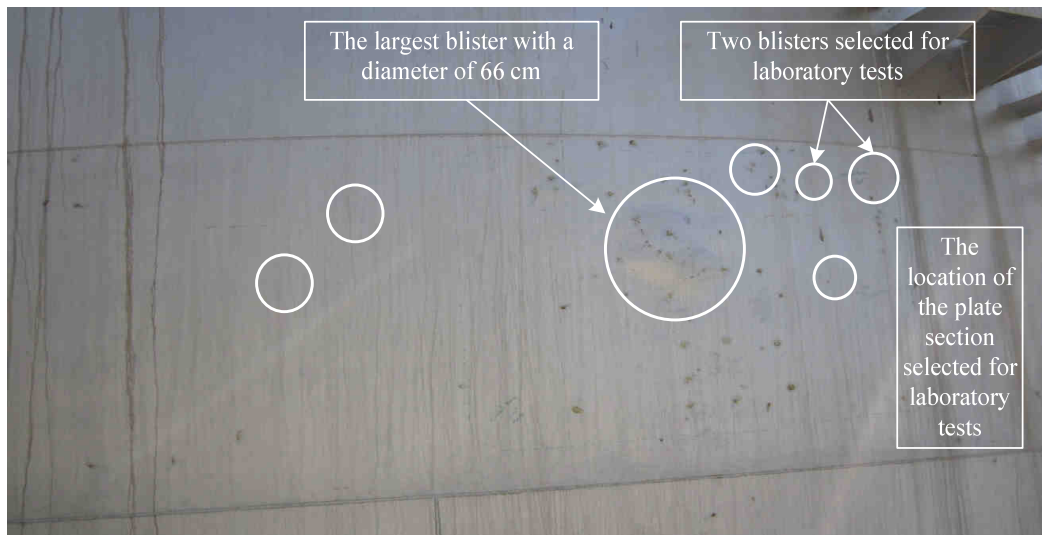
varying from 12 mm at first bottom course to 6 mm at top four courses. The height of each course is 175 cm and the total height of the tank is about 14.00 m. Post weld heat treatment (PWHT) was conducted just on the reinforcing pad of the nozzles and man ways. The tanks are used for storing crude oil of Nowrooz, Soroush, Bahregan, and Hendijan fields. The oil stored in these tanks is sour and, based on daily measurements by on-site lab in Bahregan Oil District, the amount of input H<sub>2</sub>S varies from 25 ppm to 100 ppm with the monthly average of 50 ppm. All blisters occurred on the second course of Tank #11 which had a nominal thickness of 10.66 mm. These blisters were found during a random in-service visual inspection of the tank. Some minor internal blisters and more than 10 hydrogen blisters in the outside surface were observed the diameter of one of which was 66 cm (see Figure 1).

Figure 1 shows the storage tank shell course from which the section was extracted. A reddish brown corrosion deposit/extract was observed on the internal surface of the plate. A sample with a cross sectional area of 300 mm (width) by 600 mm (length) and a nominal wall thickness of 10.66 mm was extracted from the intact area of the second course plate near the damaged area for conducting non-destructive evaluation (NDE), chemical composition, and hardness tests; the locations are shown in Figure 1. Furthermore, two blisters (the smallest blister found during the internal inspection and another larger external blister near it) were selected for microstructural examination and fracture surface investigation as shown in Figure 1. The reason for selecting one small and one large blister was to conduct further studies on the fracture behavior of the plate during the blister growth.

**Figure 1**  
The damaged second course plate before repair

Since the other plates in this tank have the same material and same fabrication conditions, it is recommended to apply an internal coating to eliminate or reduce the hydrogen charging in order to prevent further generation and growth of blisters. In addition, reducing the S content to 0.002 or 0.005%, using heat treatment processes to eliminate the banding (in new plates and in the whole tank plates on site), and employing steel grades with 0.2% Cu are suggested for preventing this kind of failure in the future.

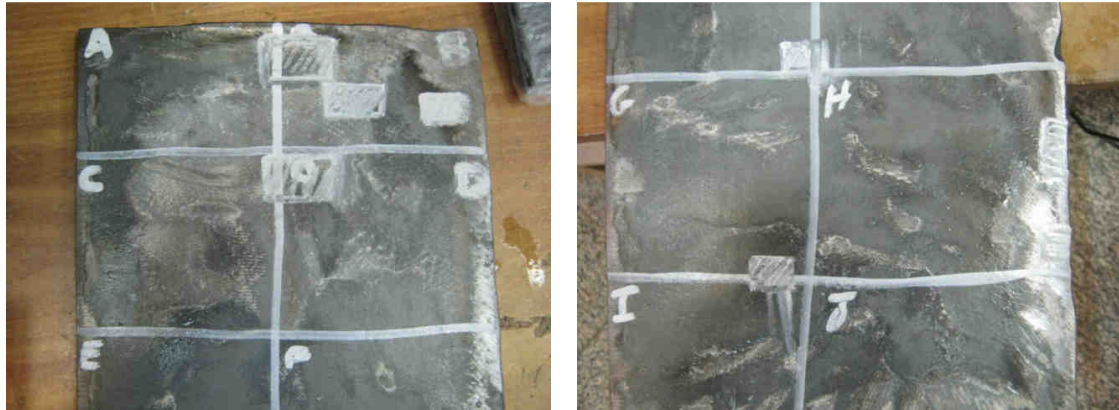
**Figure 2**

UT was conducted on the selected section near the blistered area using normal straight UT equipment. The plate was thoroughly inspected by visual examination before UT to ensure that no blisters were present. The plate was marked into smaller areas as shown in Figure 2. The UT report revealed planar imperfections distributed throughout the plate. These imperfections were distributed in zones B, D, E, G, and H with different depths from 7 to 9 mm measured from the outside surface (outside diameter) of the tank (see Figure 2).

Magnetic particle inspection (MPI) based on Yoke method was also conducted on all the four edges of the sample to validate the results of the UT and also to investigate the probable extension of the planar defects toward the edges of the sample (i.e. toward other areas of the shell course). Cutting and edge preparation was conducted by grinding to avoid overheating and metallurgical changes of the plate edges; fluorescent magnetic powder was used. All the edge surfaces were investigated in different directions of magnetic flux under UV light. Several planar, crack-like flaws were observed at different depths varying from 7 to 9 mm from the outside surface of the tank. The results of the MPI tests were

A sample plate was divided into different zones to conduct UT

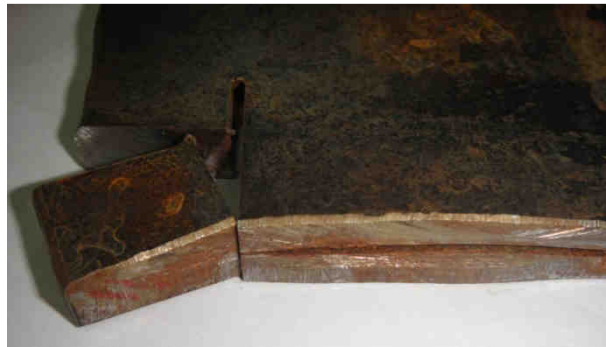
**Figure 3**

A metallographic examination sample extracted from the periphery of the blister (crack tip)

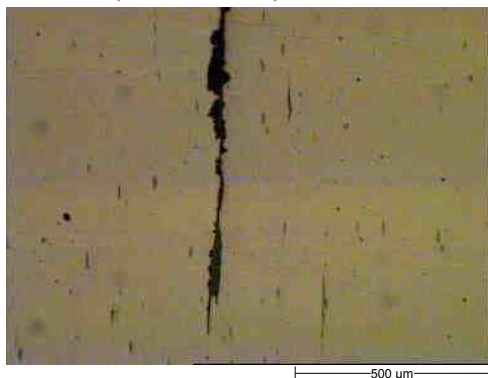
In Figures 4.a some scattered inclusions can be observed elongated in rolling direction. As will be discussed later in energy dispersive spectroscopy (EDS) results, these inclusions mainly include S and Mn as well as other inclusions. These inclusions can also be seen at the tip of the cracks and their boundaries. As reported by Ren, inclusions are an important factor in the propagation of initiated cracks and the growth of the hydrogen blisters (Ren et al., 2008).

a. Propagation of a crack and scattered distribution of inclusions

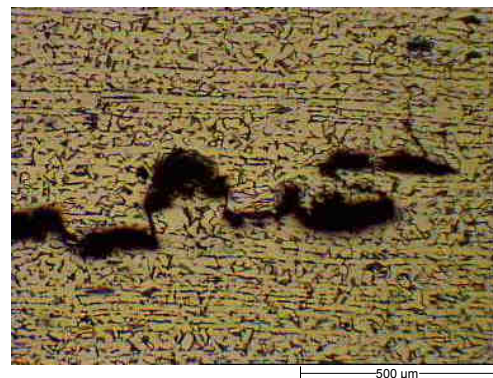
Ferrite grains (of a size of 7 to 10 G according to ASTM E 112-10) and needle-like ferrites beside pearlite grains and elongated pearlite were detected in Figure 4.b (ASTM, 2000). As it can be seen, there are ferrite/pearlite banding. The progression of cracks is parallel to the banding pearlite and follows that; however, its amount is low in this structure. Moreover, the transgranular cracks are seen and this indicates that embrittlement phenomenon may be occurred in some locations. Not only do cracks propagate in inclusion path, they grow among grains as well.

Banded pearlites are susceptible locations for the progression of cracks. Cracks tend to follow pearlite bands as well as elongated sulfides; even cracks in different bands may link up. This means that a higher elongated inclusion, or a more banding, increases steel susceptibility to HIC in a wet acidic environment (Dadari, 2011).

b. Tip of a crack and a transgranular crack

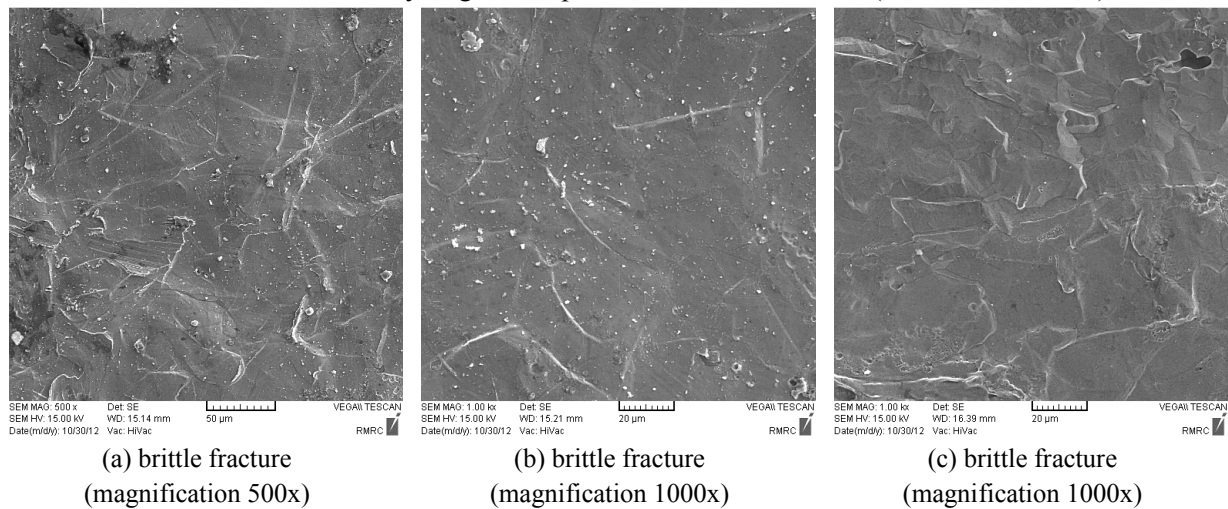
**Figure 5**

SEM images of fracture surfaces related to sample No. 4 (the small blister)

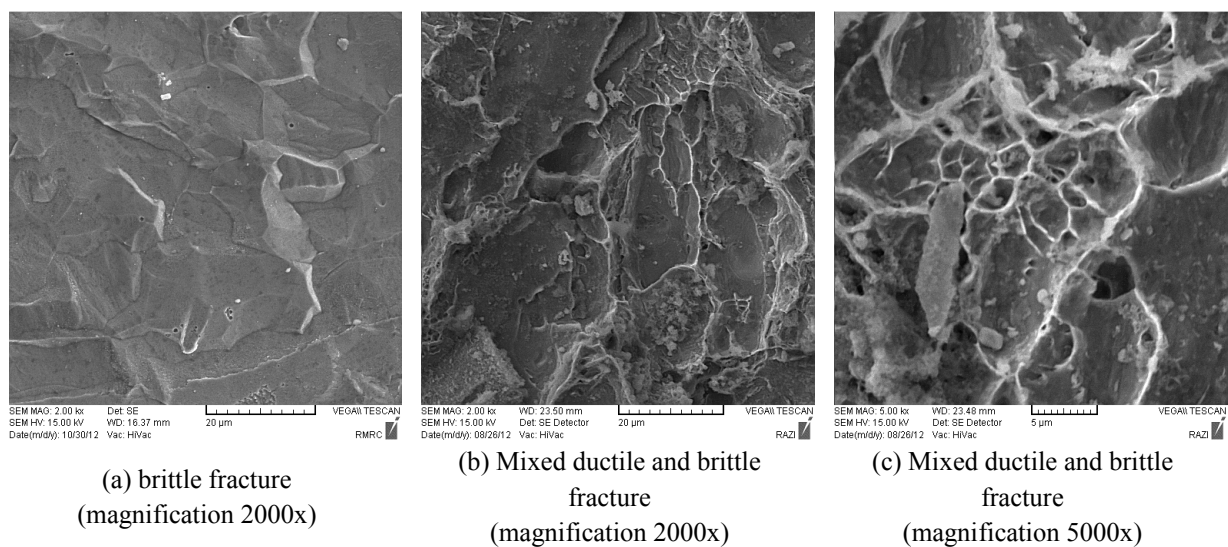
A brittle fracture can be seen in Figures 8 and 9 (the small blister) and Figures 11 and 12 (the large blister). At the same time, a case of a mixed small ductile and brittle fracture can be seen in Figure 9.b and c which are related to the smaller blister. For the case of Figure 6 with a mixed ductile-brittle surface, it can be concluded that hydrogen was present in a lower content (Herms et al., 1999).

SEM images of fracture surfaces related to sample No. 5 (the small blister)

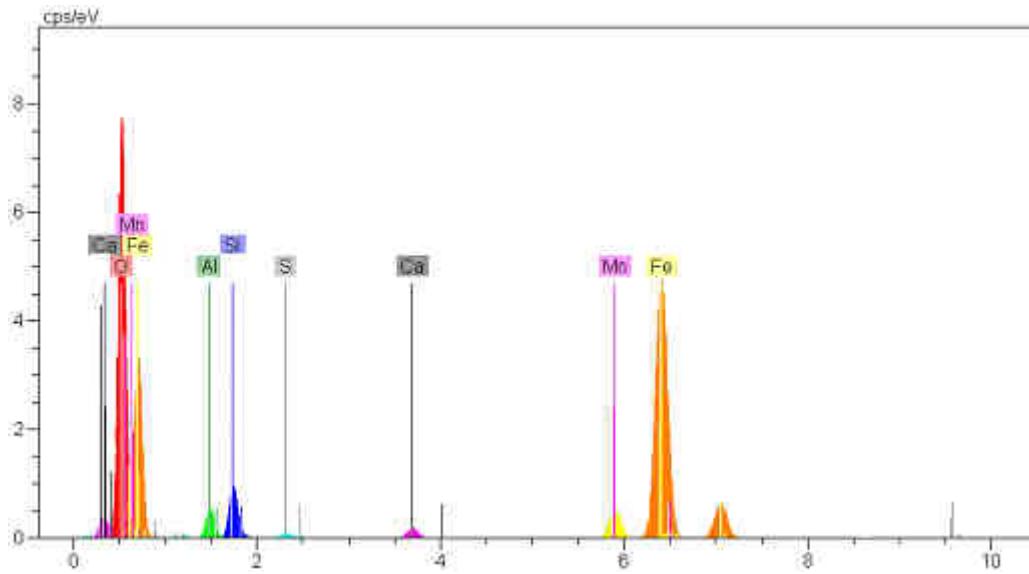
Element	unn. C [wt.%]	norm. C [wt.%]	Atom. C [at.%]
Iron	74.09	70.36	46.23
Manganese	6.23	5.92	3.95
Calcium	0.60	0.57	0.52
Sulfur	0.27	0.26	0.30
Silicon	2.34	2.22	2.90
Aluminum	1.49	1.41	1.92
Oxygen	20.28	19.26	44.17

**Figure 7**  
EDS result from the fracture surface of the small blister

It can be inferred from Figures 6.a, 8, and 9 that a step like pattern and cleavage can be seen in the fracture surface of the samples which can represent a brittle fracture. However, there are some locations not following this structure. These locations are inclusions. To satisfy this assumption, EDS was done on the samples. The EDS results (shown in Figures 7 and 10) indicate that these inclusions mainly contain Mn, S, Al, Si, and Ca.

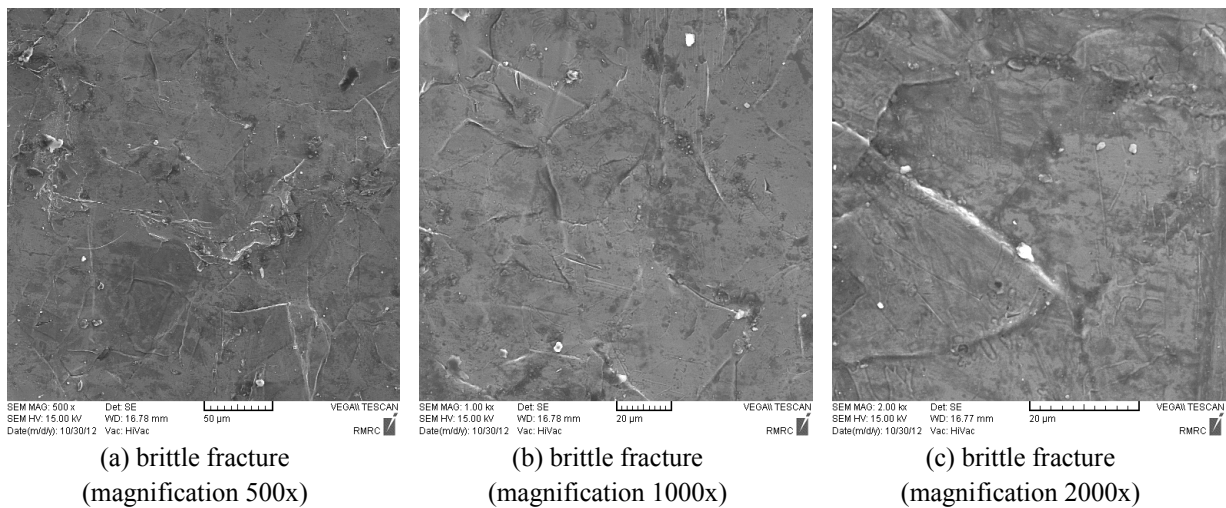
**Figure 8**  
Fracture surface of sample No. 6 (the large blister)

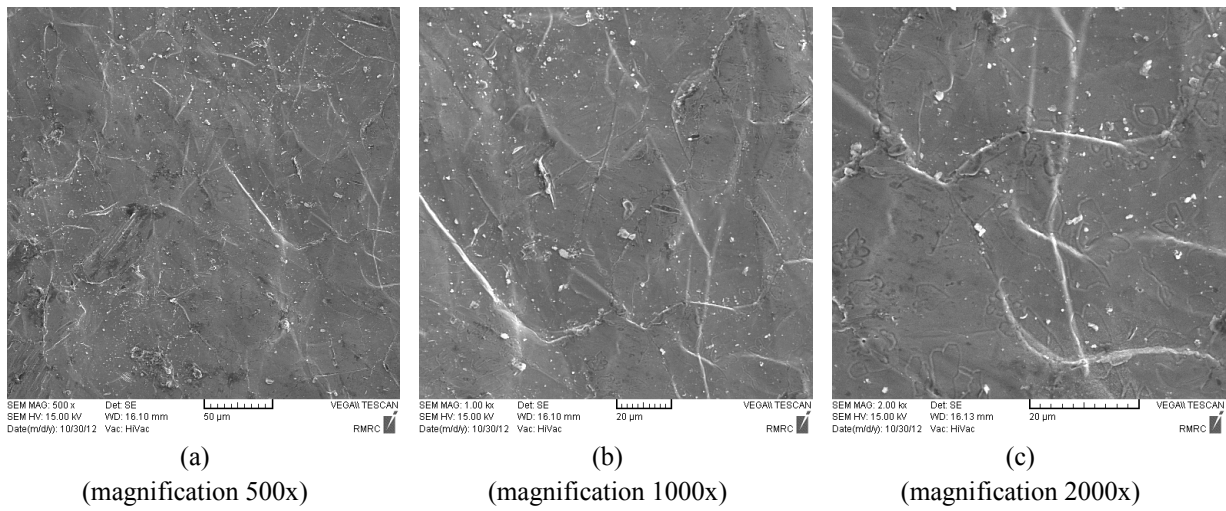
**Figure 9**  
Fracture surface of sample No. 7 (the large blister at another location)

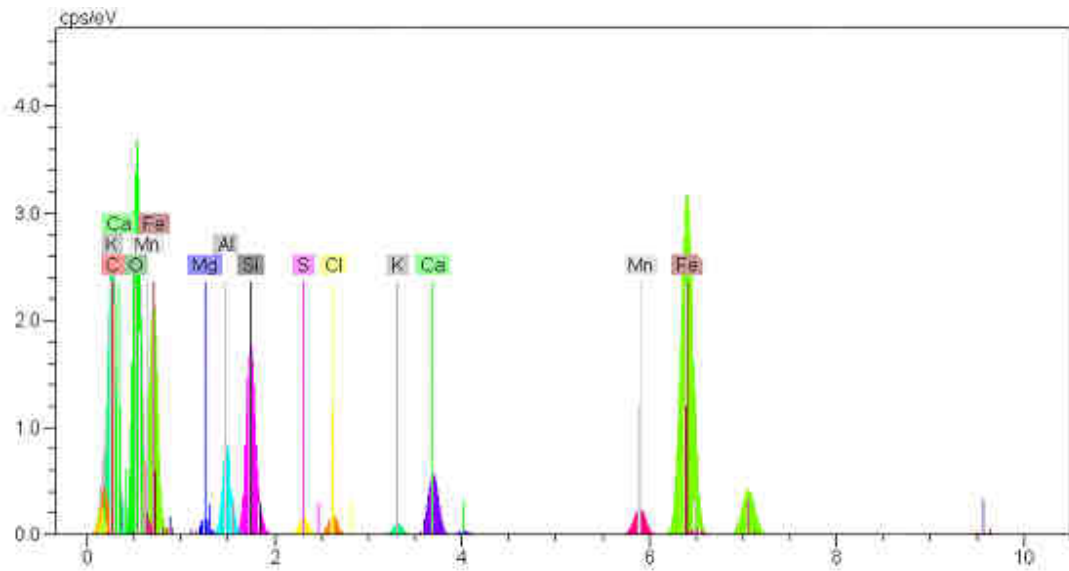
Element	unn. C [wt.%]	norm. C [wt.%]	Atom. C [at.%]
Iron	60.04	60.67	39.07
Manganese	3.24	3.58	2.34
Calcium	2.10	2.33	2.09
Sulfur	0.42	0.47	0.52
Silicon	4.68	5.17	6.63
Chlorine	0.43	0.47	0.48
Aluminum	2.28	2.52	3.36
Oxygen	15.89	17.58	39.51
Carbon	0.52	0.58	1.72
Potassium	0.31	0.34	0.31

**Figure 10**  
EDS result of the fracture surface related to the larger blister
