Iranian Journal of Oil & Gas Science and Technology, Vol. 9 (2020), No. 3, pp. 44–60
<http://ijogst.put.ac.ir>

Investigation into Mechanism of Hydrogen Induced Cracking Failure in Carbon Steel: A Case Study of Oil and Gas Industry

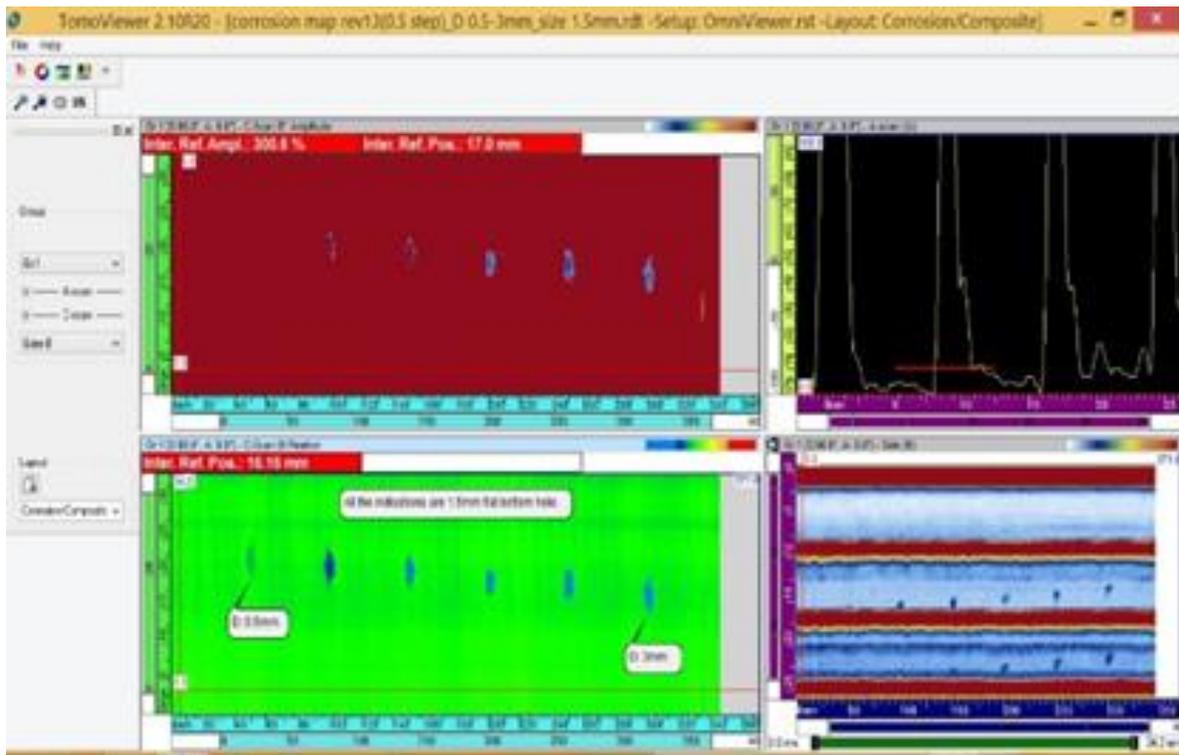
Figure 4

Scanning on the demonstration block approved that the flat bottom holes (FBH) with a size of 1.5 mm and greater, with a depth of over 1 mm, and a significant diameter can be detected. However, the precise measurement is not possible due to the lower sound energy of the returned signal (Figure 4 and Table 6a).

A schematic of the scanned data of the series of flat bottom holes with a size of 1.5 mm and a depth ranging from 0.5 to 3 mm.

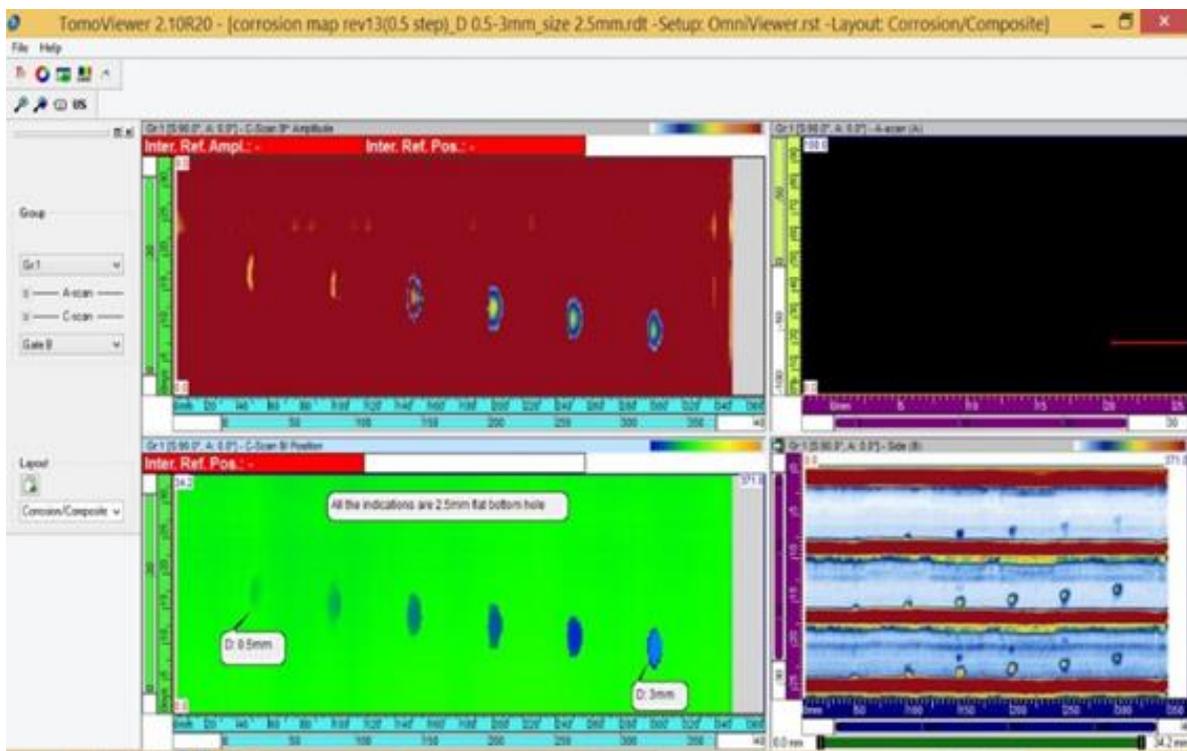
Figure 5

A schematic of the scanned data of the series of flat bottom holes with a size of 2.5mm and a depth ranging from 0.5 to 3 mm.

For the reflectors with a size of more than 2.5 mm, all the indications at a depth of 0.5 mm and higher can be detected and sized with enough signal energy and measurement accuracy (Figure 5 and Table 6b).
