Iranian Journal of Oil & Gas Science and Technology, Vol. 10 (2021), No. 4, pp. 31–42
<http://ijogst.put.ac.ir>

Failure Mechanisms and Solutions for Fin-Pass Rolls Repair-Ring at an Electric Resistance Welding Pipe Plant

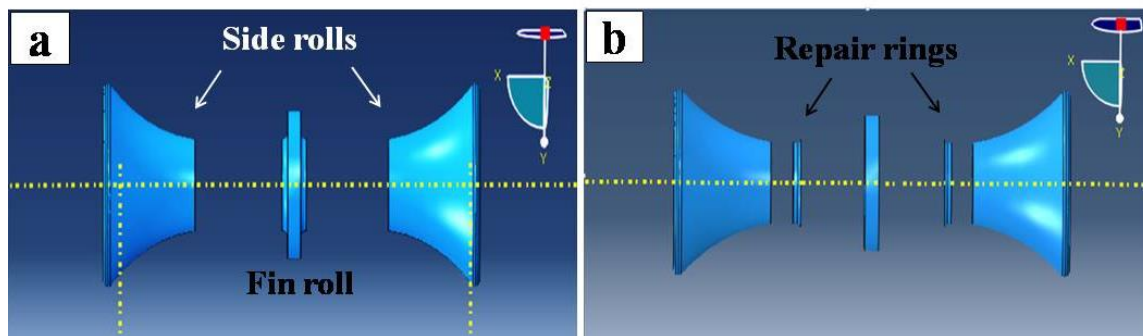
Figure 1

The fin-pass rollers investigated in this study had three pieces, and their schematic view is shown in Figure 1a. These rollers are used to adjust the contact edges of the pipe prior to welding in the ERW pipe manufacturing line. Its middle part, which has the function of adjusting the edges of the joint, is called the fin roll, and its side parts which form the cross section of the sheets, are called the fin side rolls. The first stage of the repair process was removing the damaged portions of the roll by grinding. Then, it was replaced by two rings with the same geometry made from AISI D2 steel (Figure 1b). The

a) A schematic view of the three-piece fin-pass roll and b) a schematic view of the five-piece fin-pass roll.

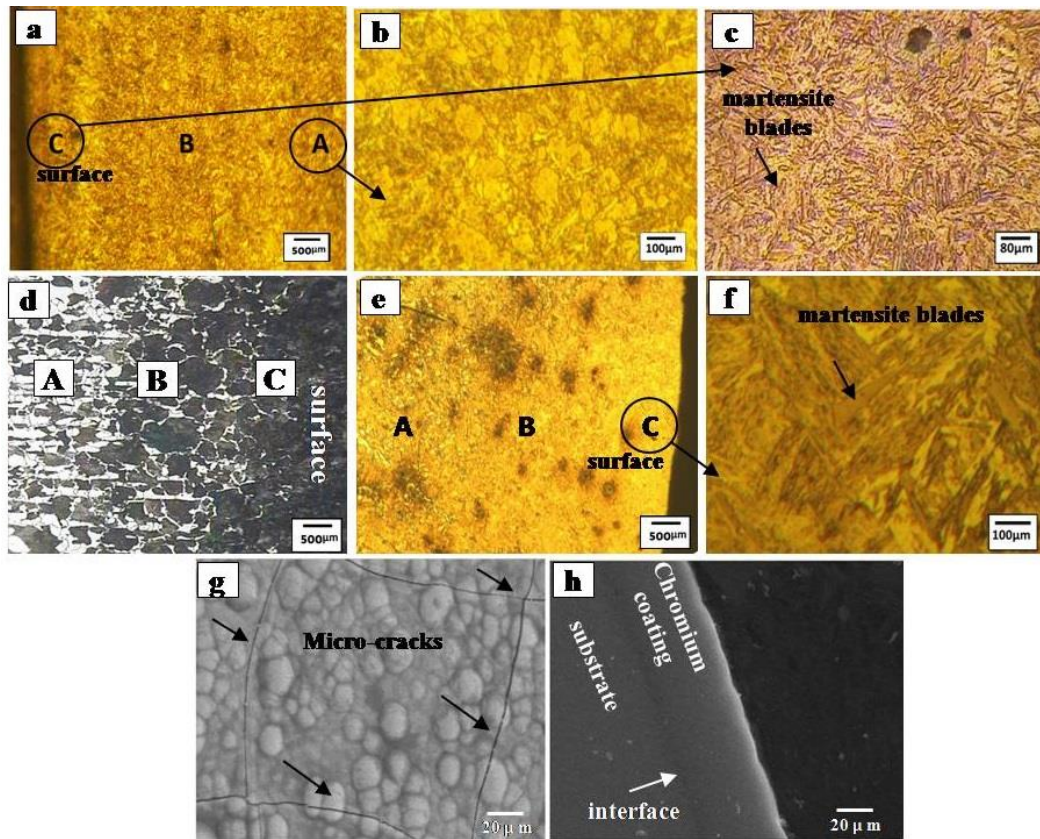
Figure 5

Optical microscopic images of a) the cross-sectional microstructure of case hardened AISI 4140 sample, b) the higher magnification of the surface area in image a, c) the higher magnification of the deeper area at image a, d) the cross-sectional microstructure of carburized P20 steel before quenching, e) the cross-sectional microstructure of carburized AISI P20 steel after quenching, f) the higher magnification of the deeper areas in image e, g) the SEM image of the hard chromium electroplated AISI 4140 sample, and h) the cross-sectional SEM image of the hard chromium electroplated AISI 4140 sample.

Figure 5d shows the light microscope image of the cross section of carbonized AISI P20 steel prior to the quenching operation. It is evident that the surface microstructure is cementite, and with moving inwards, the microstructure changed to ferrite. The presence of ferritic microstructure in the depth of this sample indicates the high toughness in these areas.

Figure 5e illustrates the cross-sectional image of this sample after the quenching operation. In addition, Figure 5f shows the microstructure near the surface regions of this sample at a higher magnification. It is evident that after quenching, the surface microstructure of this sample is martensitic, which can lead to high surface hardness. Figure 5g and 5h shows the scanning electron microscope images of the hard chromium electroplated AISI 4140 steel from its surface and cross section, respectively. The surface morphology in Figure 5g contains many colonies and microcracks, which is similar to the results of previous studies (Fedrizzi, 2002; Lindsay, 1997). The surface colonies are collections of the grains. Observation of the microcracks indicates the high residual stresses in the hard chromium coating. The high residual stresses between the atoms, in this case, will retard the movement of the dislocations and thus increase the hardness [Sun, 2020]. The surface hardness of this specimen was 1200 HV, which is significantly higher than that of its substrate (about 60 Rockwell). Figure 5h shows that the interfacial adhesion between the coating and the substrate is well, and the thickness of the coating is 50 μm approximately. Figures 6 and 7 show the indenter projections of the microhardness tests from the surface toward the depth for case hardened AISI 4140 and carburized AISI P20 steel, respectively.

As mentioned in the failure analysis section, a potential solution to extending the service life of the repair ring is to use an alternative material with higher toughness and to use a suitable surface treatment to achieve higher wear resistance. This study proposed low-carbon AISI P20 steel and medium-carbon AISI 4140 steel alloys with higher toughness than high-carbon AISI D2 steel. For low-carbon steels, surface carburization and medium-carbon steels case hardening and hard chromium plating can be suitable surface treatments to increase the wear resistance. Thus, the carburization of AISI P20 steel, the case hardening, and the hard chromium electroplating operations on AISI 4140 steel were performed. Figure 5a shows the cross-sectional morphology of the case hardened AISI 4140 steel. Further, Figure 5b and 5c shows the microstructure of the near-surface areas and the deeper portions of this specimen at higher magnification, respectively. Observation of martensite blades on the surface of this steel can lead to high surface hardness. In addition, the pearlite-ferrite microstructure in the deeper portions can indicate the high toughness in these areas.

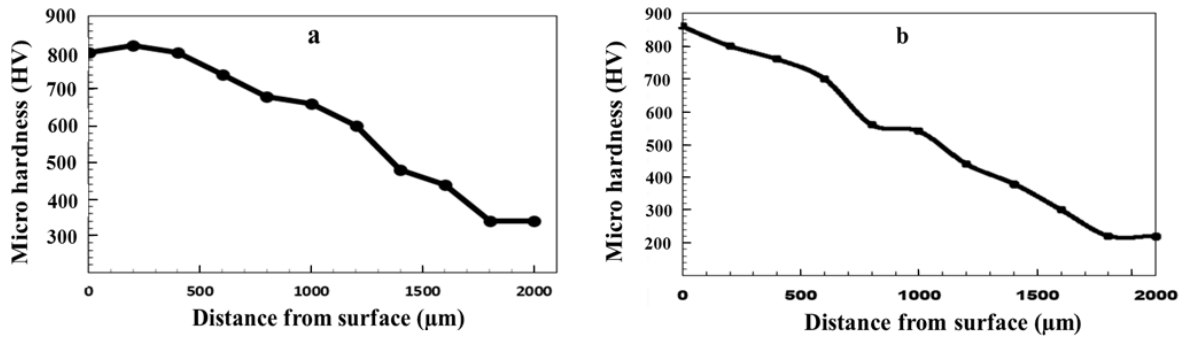
Figure 6

a) The change of microhardness values versus distance from surface for case hardened AISI 4140 steel and b) variation of microhardness values versus the distance from the surface for carburized AISI P20 steel.
